Com.X

Hybrid IP PBX / Gateway

Troubleshooting Guide

(Com.X 1.2 product release)

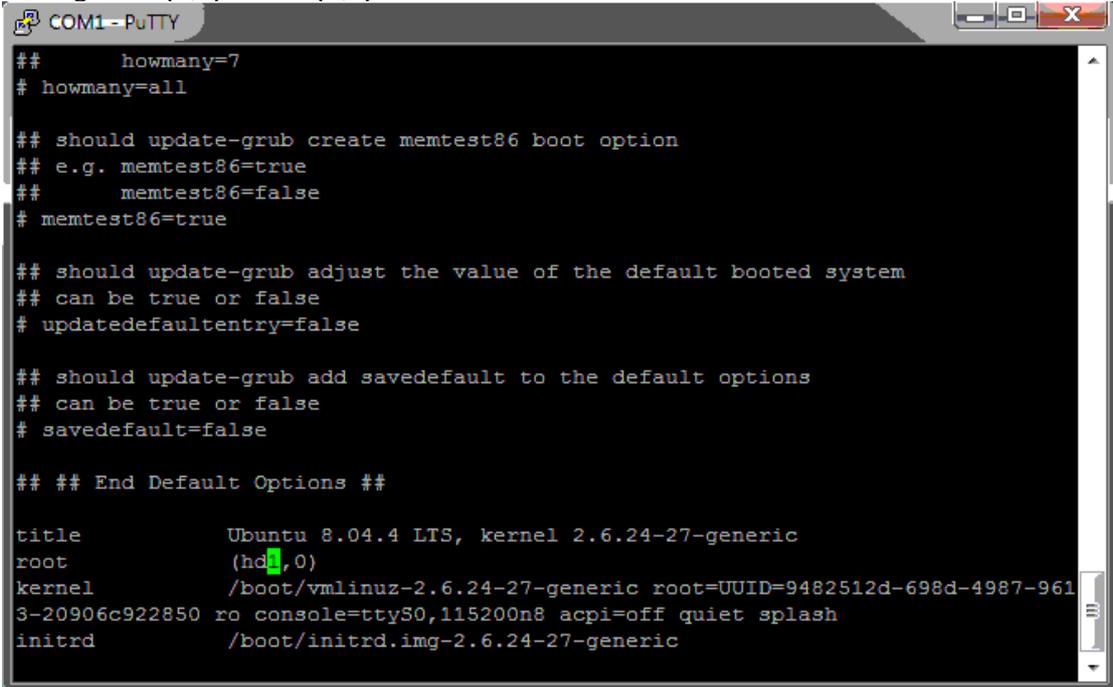
- Should subsequent boot present Grub error 21, re-insert the USB drive and reboot. The system should now boot from the *solid state drive*. Log in and edit the boot configuration as follows:
 - `cd /boot/grub`
 - `sudo vi menu.lst`

- Change hdd(1,0) to hdd(0,0)

```
COM1-PuTTY
##      howmany=7
# howmany=all

## should update-grub create memtest86 boot option
## e.g. memtest86=true
##      memtest86=false
# memtest86=true
